CASE STUDY: Metatarsal Stress Fracture

By Dr. Neil Humble, DPM

CLINICAL BIOMECHANICS: Forefoot Dynamics and Injuries

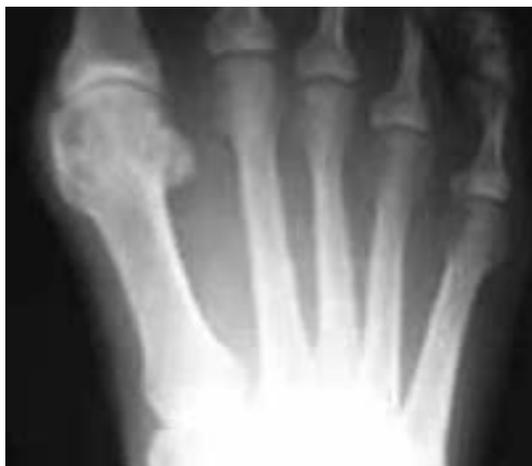
Figure 1

Radiographs were performed and revealed no osseous abnormality (Figure 1). A triple phase technetium bone scan was then ordered and revealed a stress fracture of the second metatarsal right foot (Figure 2).

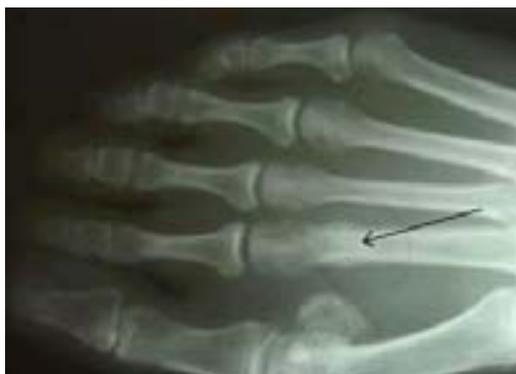
Figure 3

A follow-up radiograph was performed and callus formation was noted. Further tests were undertaken to inquire about the etiology of the injury (Figure 3). A gait and pressure analysis was performed that showed biomechanically increased pressure beneath the second metatarsal and excessive midstance subtalar and midtarsal joint pronation. She was referred back to her family doctor for bone density testing which came back normal for her age.

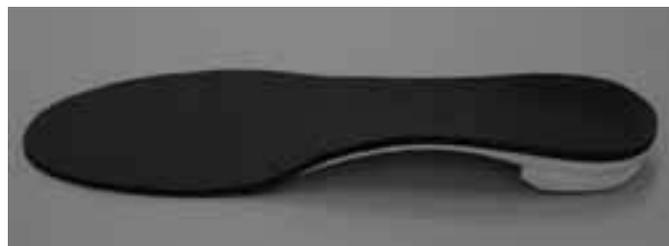
Figure 4

The following are features of this orthotic (Figure 4):

1. Semi-rigid polypropylene shell with intrinsic forefoot posting and extrinsic rearfoot posts
2. Cushioned neoprene top cover
3. Cushion cork accommodation sub-second metatarsal
4. A metatarsal pad was added at a later date

She was instructed not to increase her weekly mileage by more than 10%. A custom foot orthotic was fabricated to control the unstable midstance motions that may have been contributing to fatigue in the intrinsic and extrinsic muscles and to reduce pressure on the second metatarsal.

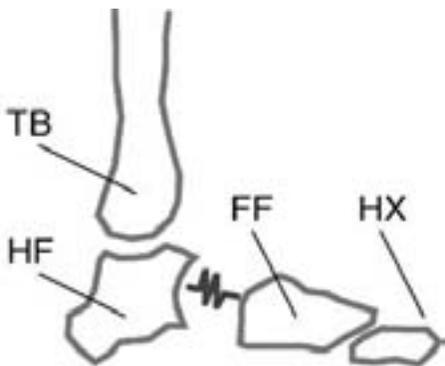
The forefoot has been defined as the region of the foot that is distal to the tarsometatarsal joints. Included in this region of the foot are the 5 metatarsals, 14 phalanges and 2 sesamoid bones. In order to measure forefoot kinematics, the researcher must position a cluster of markers on the rearfoot (HF) and on the forefoot (FF) (Figure 1).
